Test Report

Product Name: LEDJ Display Floor

Product Model: LEDJ454

Report NO. TMC210913106-RL

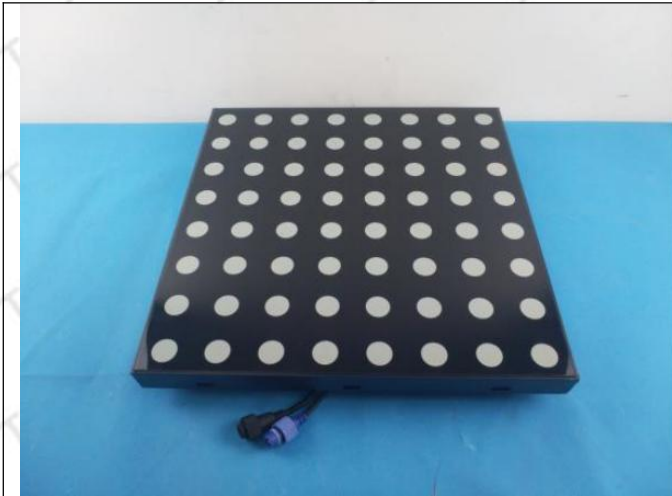
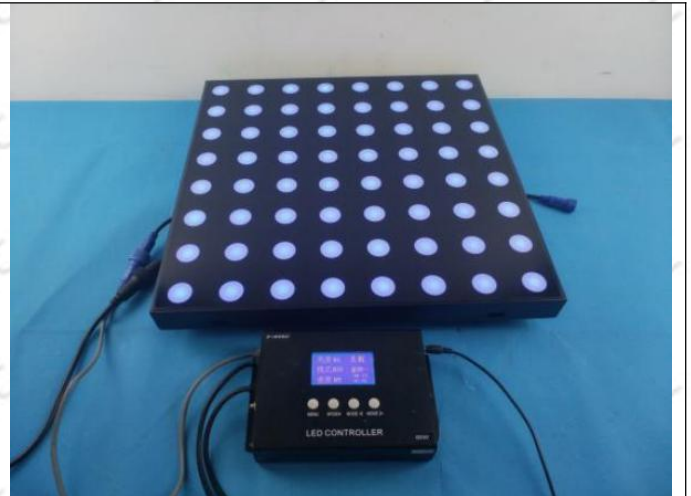
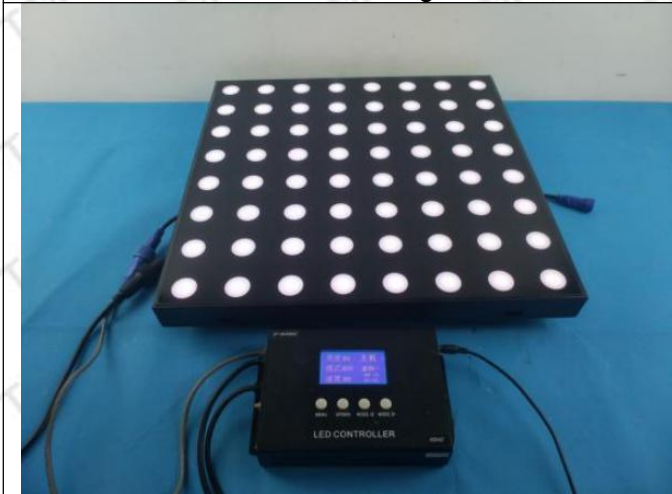
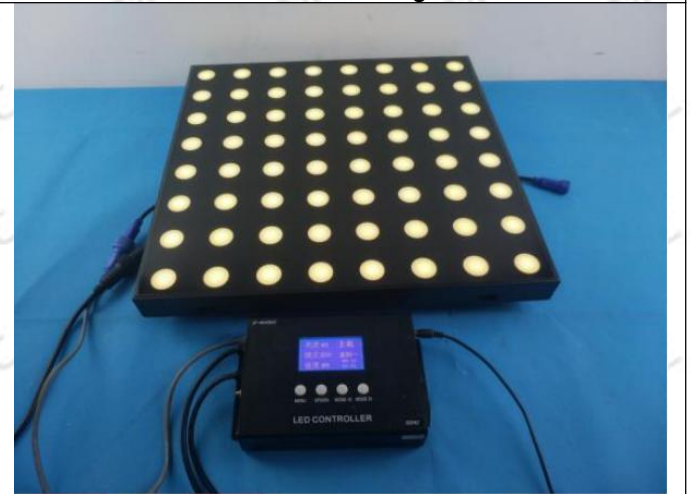
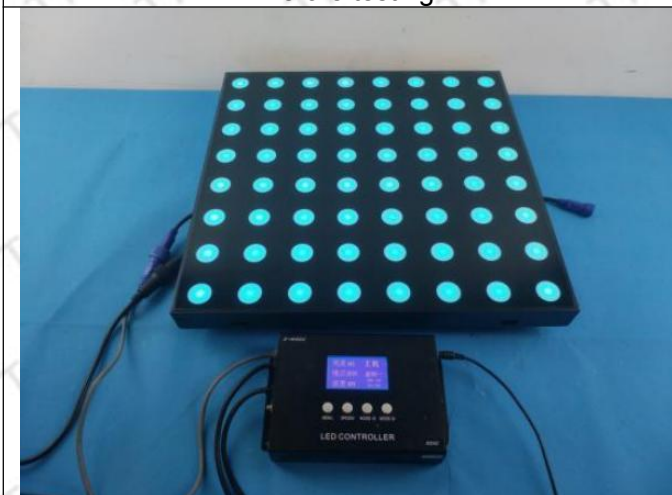
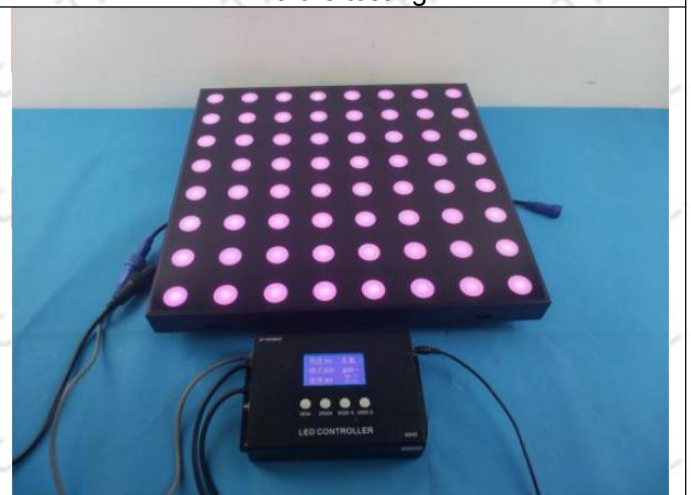
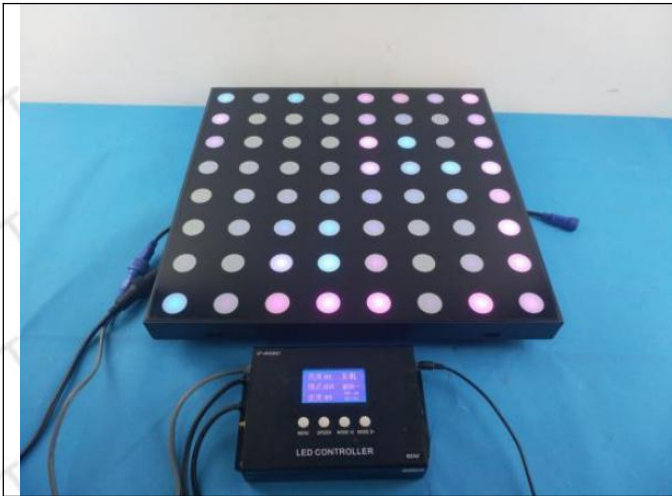
Before testing

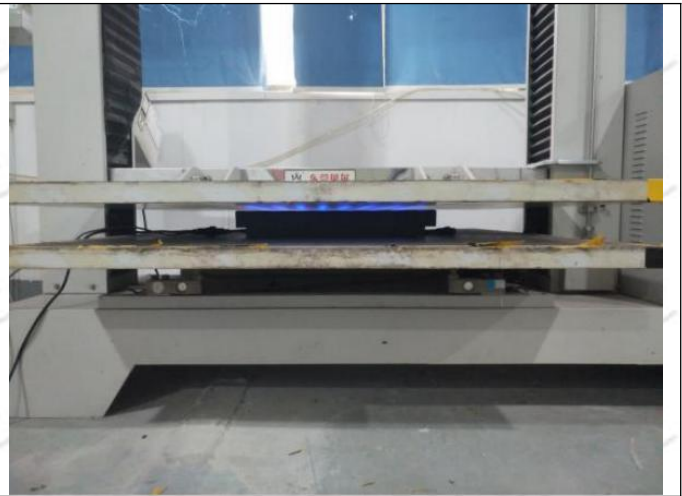
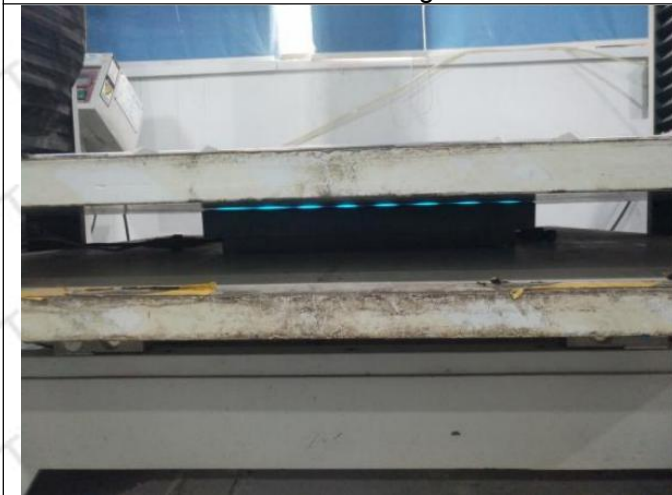
Continuous pressure at 125kg for 30 minutes. During the test the sample is run on auto mode through its programs.

In testing

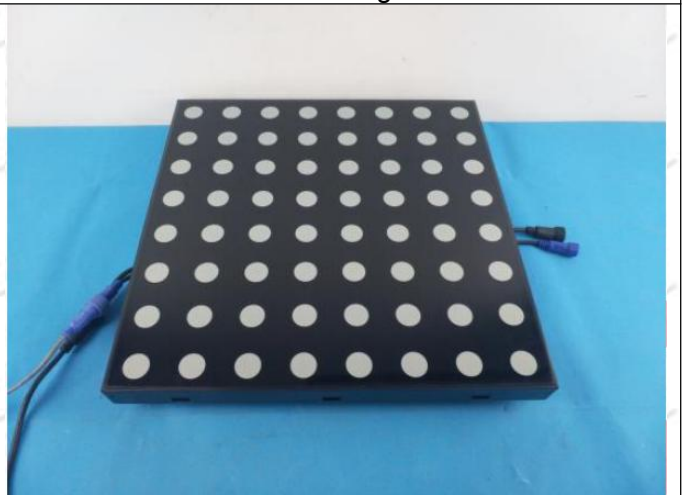
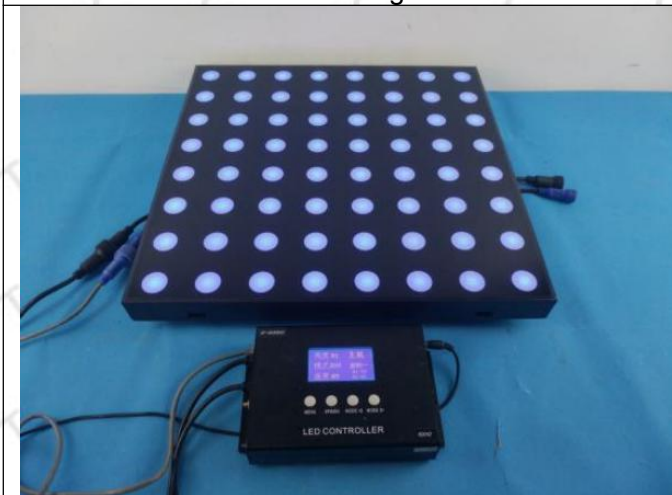
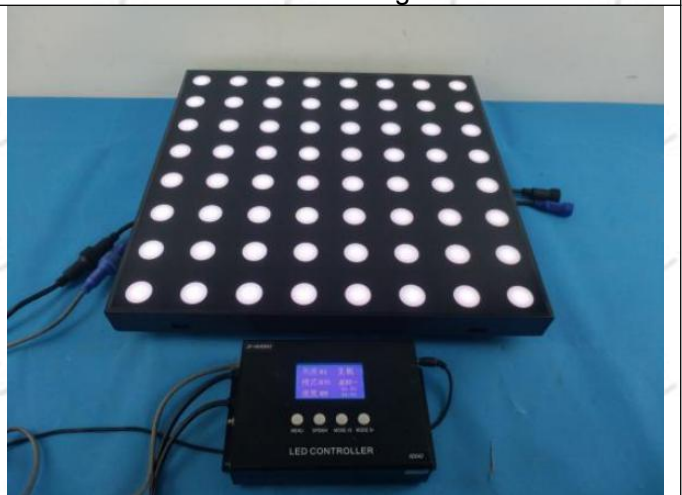
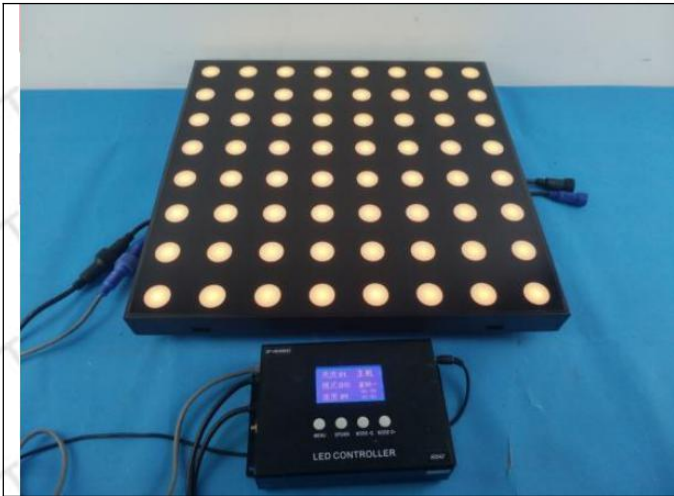
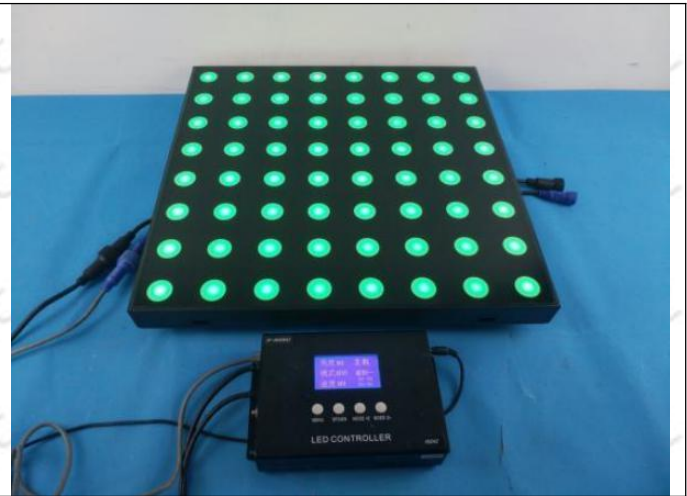
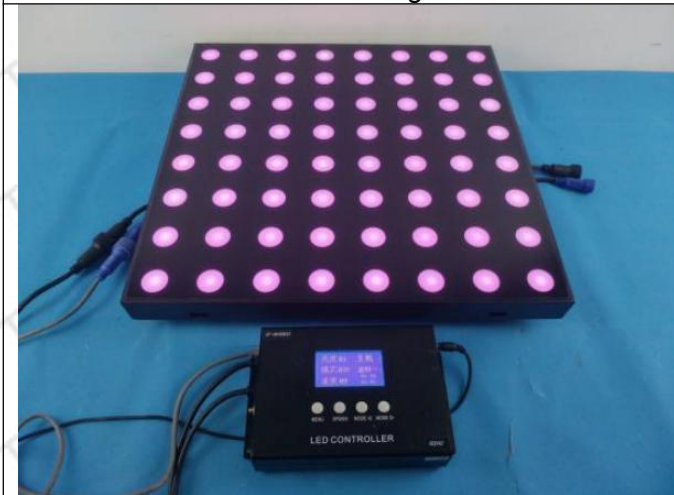
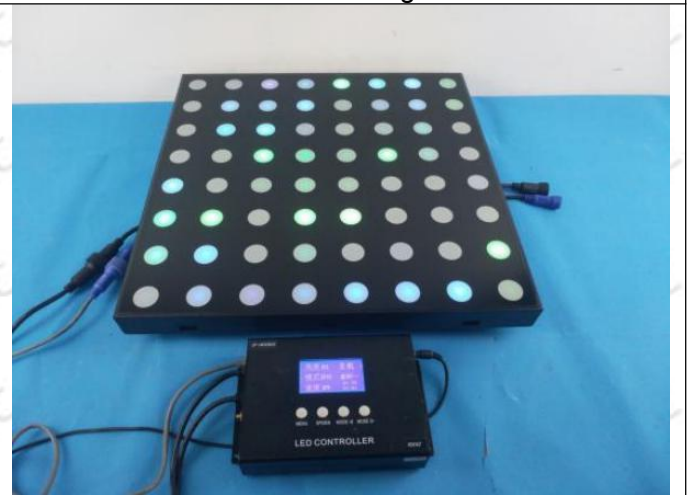
Sample No.	Test Results	Conclusion
210913001	After the test,the sample has no obvious deformation in appearance and normal function.	Data

After testing

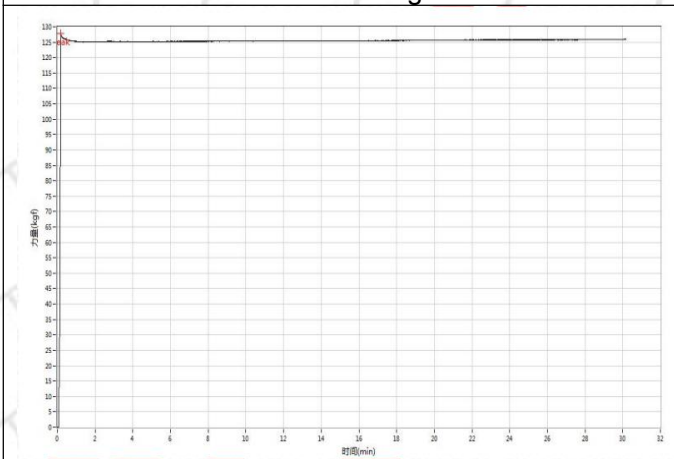
Test curve
